BLIGHT & SUBSTANDARD DETERMINATION STUDY

Agromac Sub - City of Gering, NE

RM200232-00

November 24, 2020

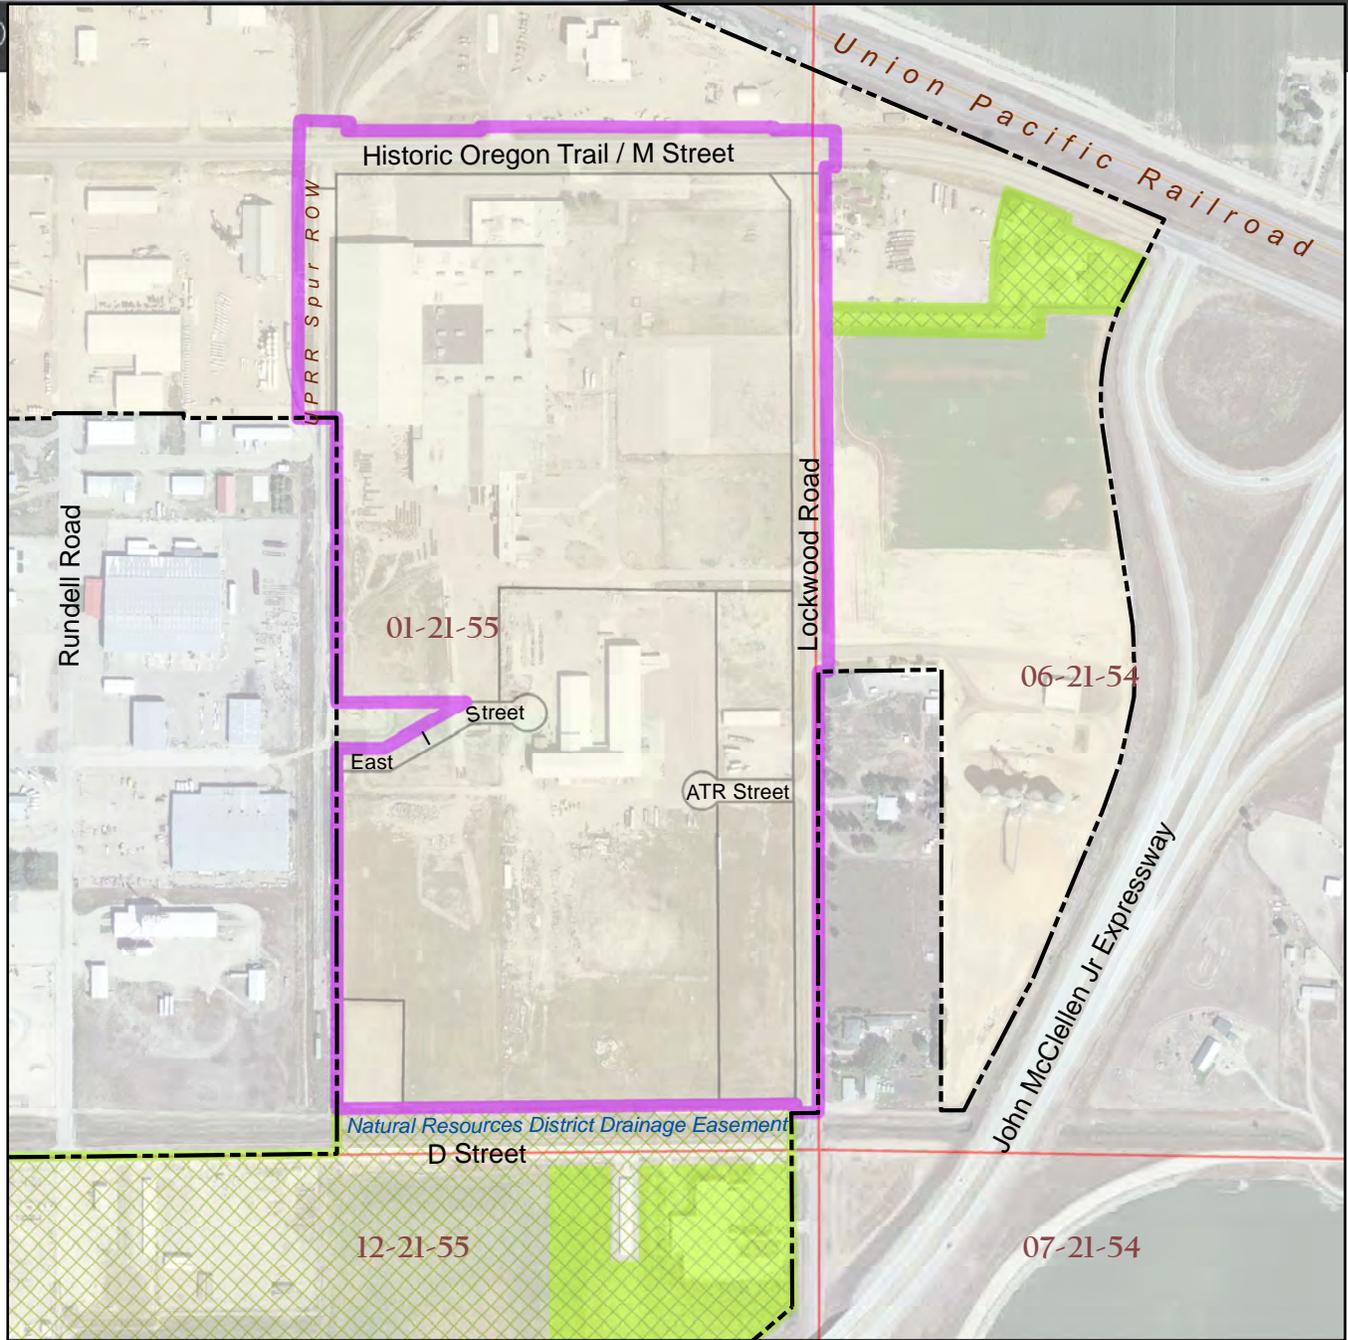
Blight Analysis Area

- Study Area
- Study Area Parcel
- Existing Redevelopment Area
- Current Redevelopment Site
- Corporate Limits
- Section

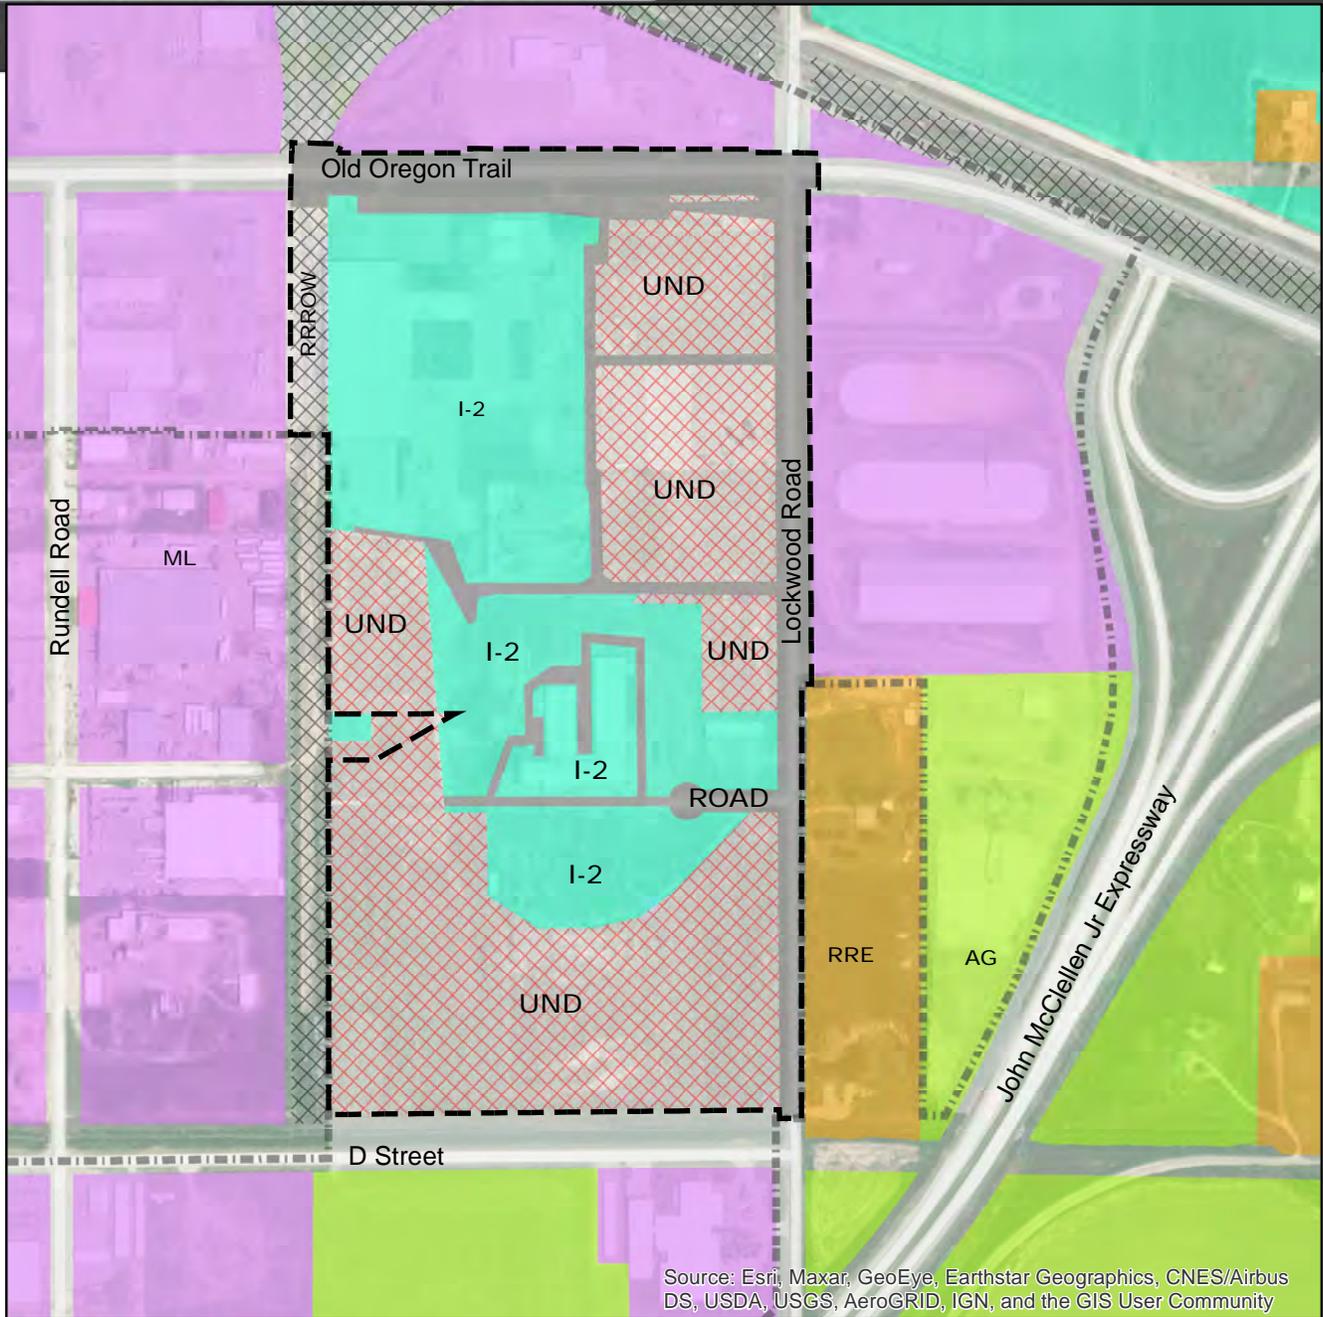
Existing Land Use

- Corporate Limits
- Study Area
- Land Use**
- Agricultural
- Light Manufacturing/Industrial
- Heavy Manufacturing/Industrial
- Heavy Industrial
- Rural Residential
- Road
- Railroad ROW
- Undeveloped/Vacant

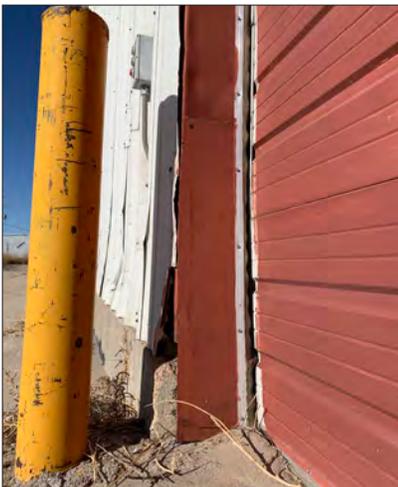
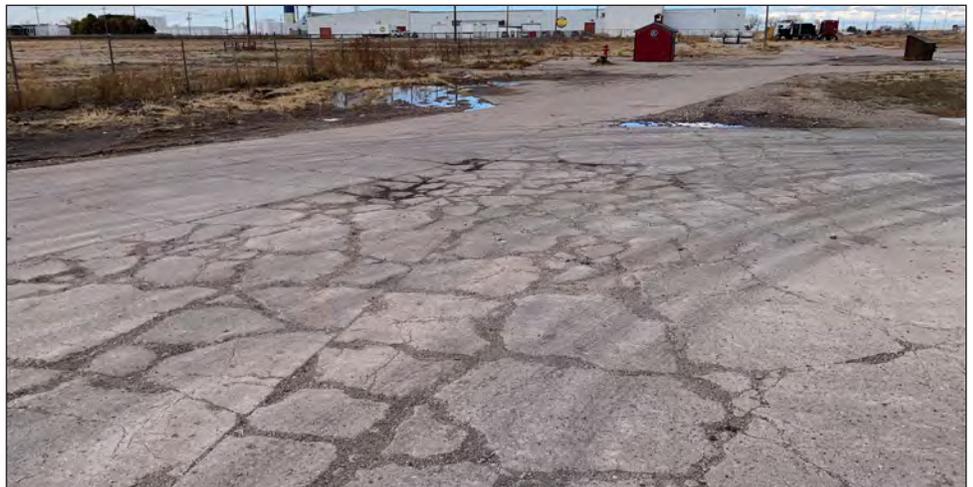
Defective or Inadequate Street Layout—Street Conditions and Accessibility

Overall, there are **four** city streets or alleys within the Study Area. ATR Street is an unpaved cul-de-sac platted city street providing access from Lockwood Road midway along the east side of the Study Area. ATR Street has the appearance of a private drive with gates that could prevent access from Lockwood Road. East I Street is a platted city street to provide access midway along the west side. However, East I Street has not been constructed as platted in this subdivision. The Study Area is bordered on the south by D Street, but there are no accesses as the Natural Resources District canal easement lies between the Study Area southern boundary and D Street. On the west, the Study Area is bordered by a 50 foot wide railway spur. Old Oregon Trail forms the north border of the Study Area, and the east border is Lockwood Road. Existing city street conditions within the Study Area present difficulties for efficient vehicular movements and emergency access. The surface condition of unpaved private access roads/alleys in the Study Area is fair to poor due to lack of surfacing material, potholes, and lack of proper drainage. The **unpaved** trail (East I Street) traversing across the railway spur onto the west side of the Study Area providing access to the electrical substation is partly on private property and does not follow the platted street, nor does it connect to the Study Area properties and structures as platted. The **lack of connectivity** and **poor surface condition** of this public street is a contributing factor to the Study Area blight and substandard condition.

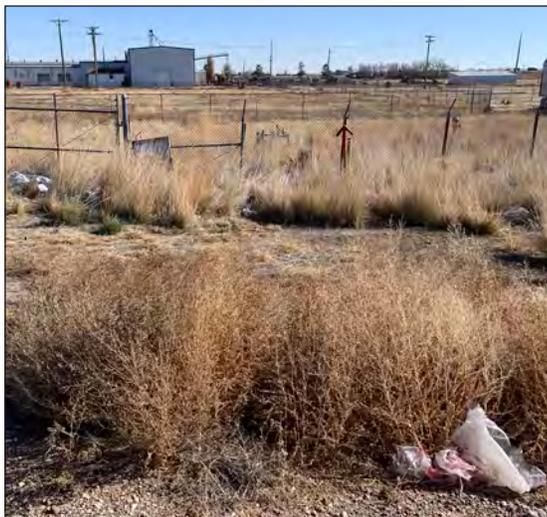
Debris accumulates in ditches, and along fences. Several significant examples of debris were noted in field observation. This debris included everything from construction materials, trash, pile of tires, large piles of broken concrete, piles of flammable debris near structure with graffiti warning no smoking near building, and excessive discarded debris accumulating along fencing.

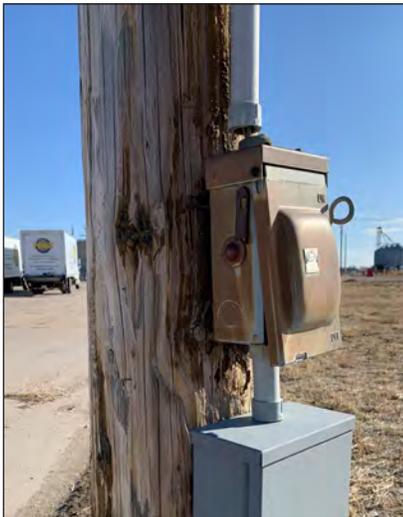
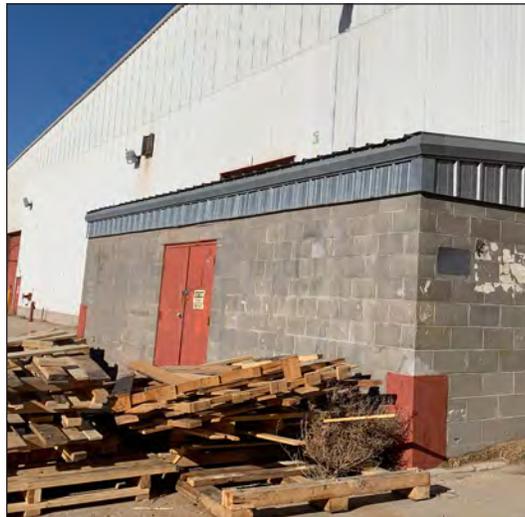
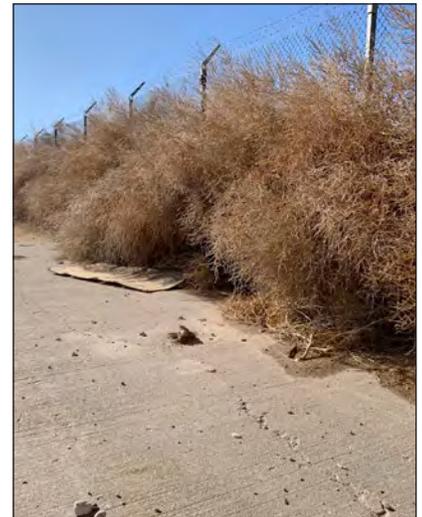
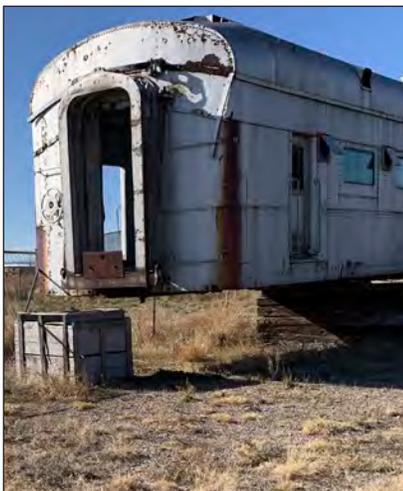
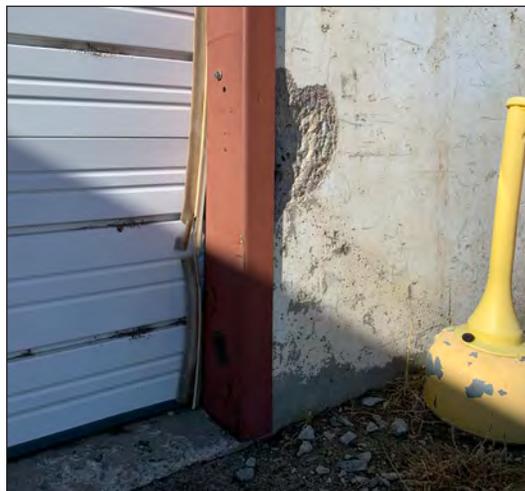
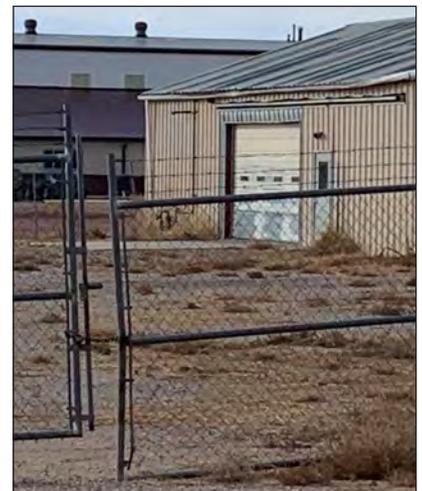
Improper Subdivision or Obsolete Platting

The lack of proper platting has caused a hardship with road networks. East of Rundell Road, on the west side of the Study Area, an unpaved 2-track trail leads eastward from I Street providing the only access to a city electrical substation and requires crossing a railroad spur ROW, which could be occupied by unattended rail cars. While platted, I Street was never constructed in the Study Area, and fences between properties in this area do not follow platted lot lines. On the east side of the Study Area, ATR Street provides the only access to an internal parcel, and it was noted that gates in place could be used to close off this access at its entrance along Lockwood Road. The southwest parcel in the Study Area has no public access points—its west edge is blocked by a railroad spur occupied by large piles of concrete, and its southern edge is bordered by the Natural Resource District canal, while the north and east lines border a parcel of different ownership.

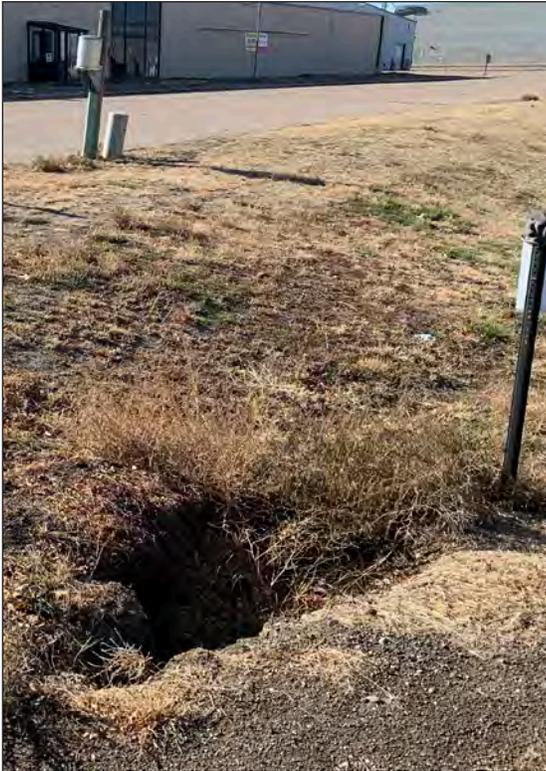
There are no public sidewalks throughout the Study Area. Existing private surfaced parking and storage areas have deteriorating surfaces that are cracked, crumbling, and contain numerous potholes. One of two public streets is unpaved, while the other has not been constructed as platted and is represented by an access two-track trail leading to the city electrical substation.

The entire Study Area is lower in elevation than its perimeter road network. Paved and unpaved roads, drives and parking surfaces are deteriorating and do not have sufficient drainage. Along Old Oregon Trail, drain pipes appear to be partially blocked with ends submerged beneath debris in fill.

Heavy rains cause some parking lot flooding and standing water next to structures with improper drainage and lack of proper engineering design.

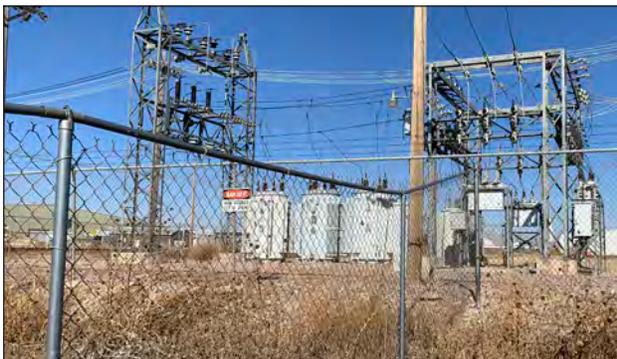
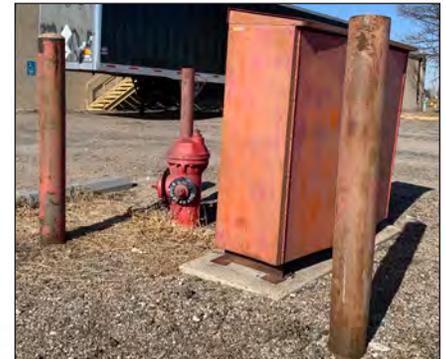
- Fire hydrant(s) on private property not in working order around three of the structures. Valve boxes were noted above grade creating a tripping hazard.
- Conditions include numerous combustible material storage, debris piles, unchecked overgrowth of tall vegetation all in proximity to deteriorating structures and surrounded by large areas of vegetation.
- **Storm water drainage** in the developed portions of the Study Area is inadequate, and backs up on or does not drain properly away from structures leaving large areas of standing water following storm events. The Study Area is generally lower in elevation than the adjacent roadways.
- The Study Area has **minimal internal streets** and is accessed on the north and east by improved and

unimproved surfaces which range in condition from fair to poor. This lack of paved streets and partially paved deteriorating and dilapidated parking creates unsafe pedestrian traverse issues in this Area and can result in limitations of access during periods of heavy rain.

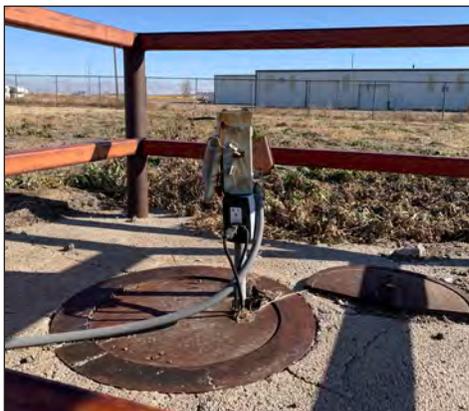
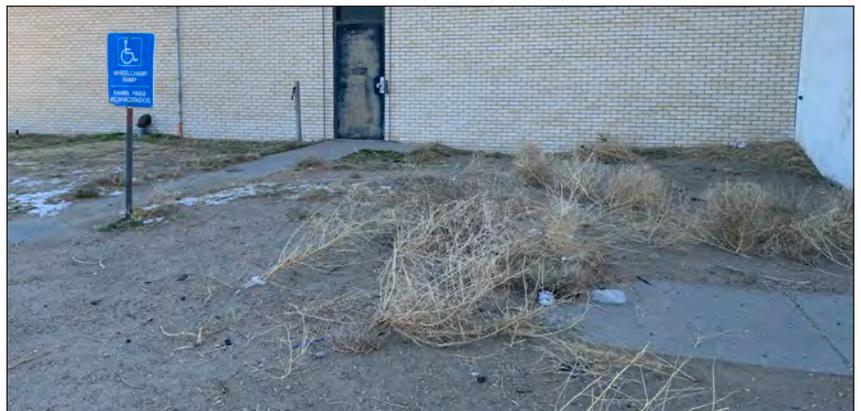
- Conditions **exist** which are detrimental to the public health, safety, morals and welfare in the present condition with the existence of no public sidewalks, out of service fire hydrants, valve boxes extending above the paved surface so as to cause a tripping hazard, and an inadequate surface drainage system throughout the Study Area—all present additional threats to health. The lack of sufficient drainage allows water to pond and stagnate, creating not only a physical hazard, but also increased potential for multiplying mosquito production, an additional health hazard to area residents.

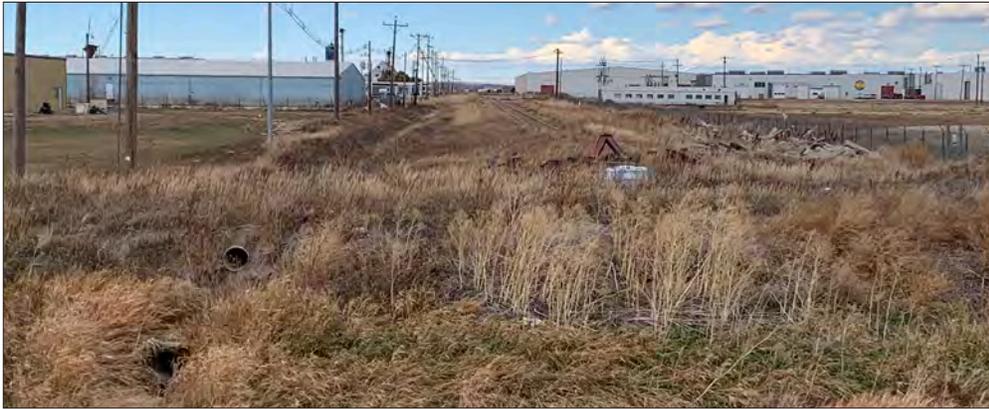
While this area is currently served by existing water distribution and wastewater collection infrastructure, portions of the water and wastewater infrastructure serving this area are 50 years old and there are opportunities for relocating a wastewater collection line from underneath a structure and constructing additional fire suppression lines in more strategic locations.

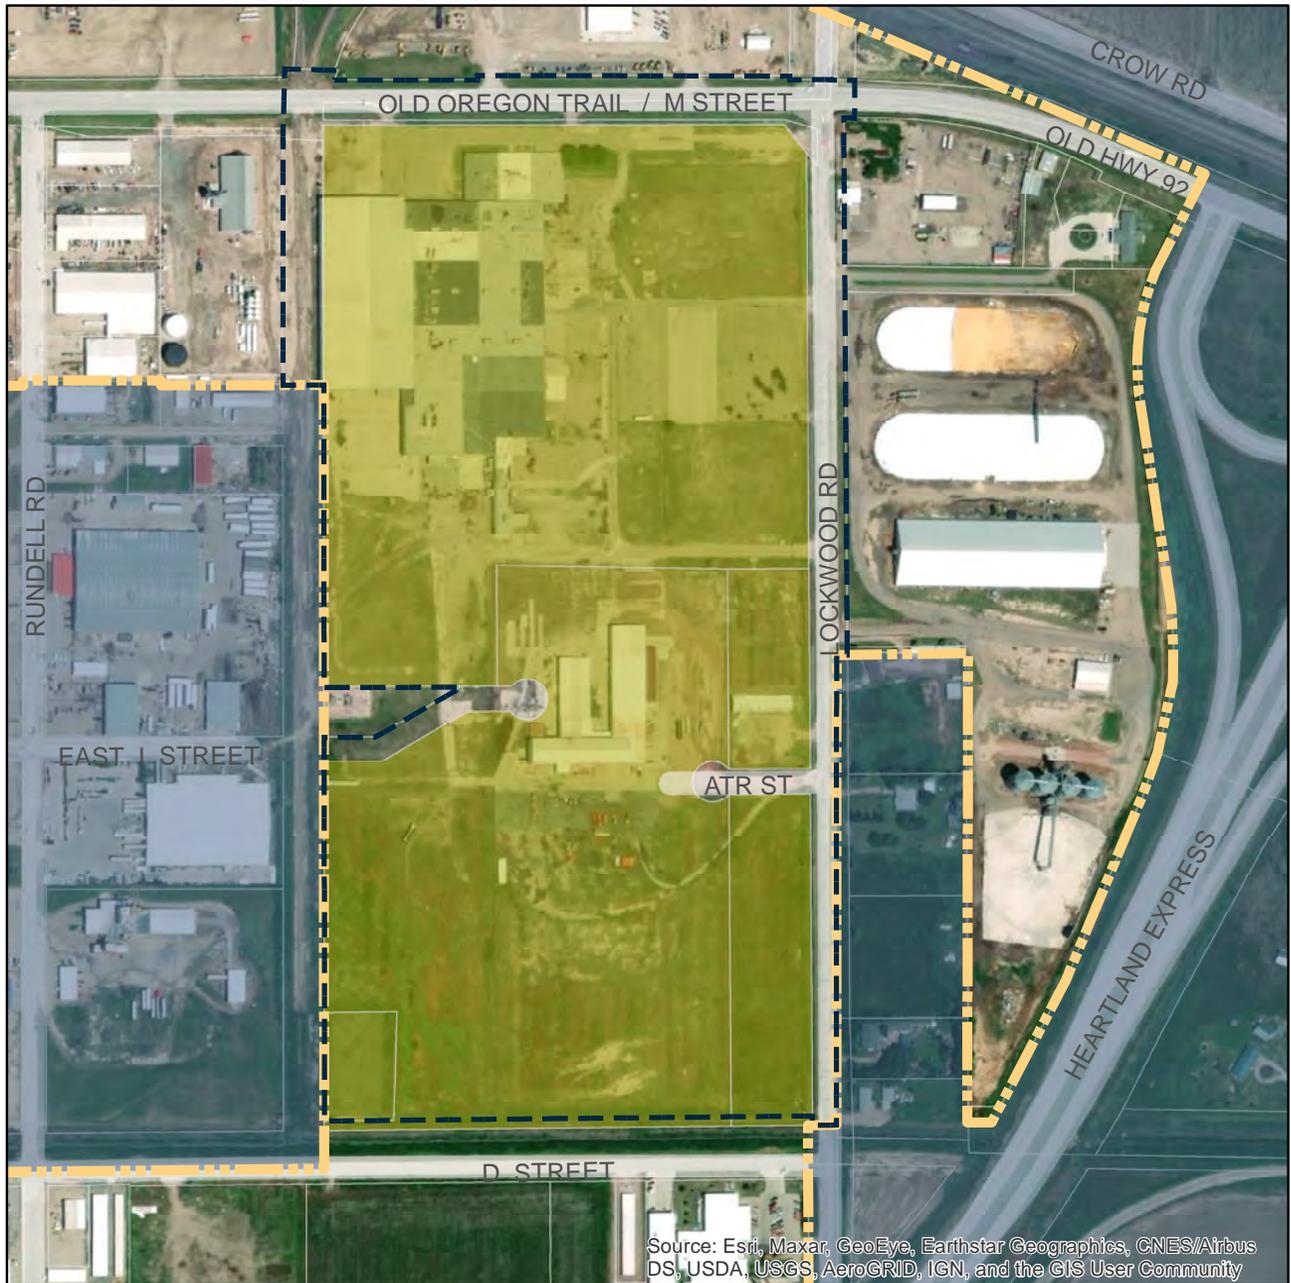
Overall Sidewalk Condition Rating

Observed sidewalk condition during physical site survey completed in November 2020, by M.C. Schaff

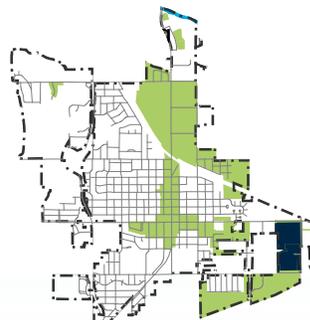
- Study Area
- Corporate Limits
- Extraterritorial Planning Jurisdiction (2-mile)
- Sidewalk Type—Condition**
- Concrete/Asphalt—Good
- Concrete/Asphalt—Fair
- Concrete/Asphalt—Poor
- Gravel/Dirt—Poor
- No Sidewalk
